# Manhole Inspection Summary

Manhole # S19Y\_\_015MH

**Location** Address: **1901 ginnalds av**

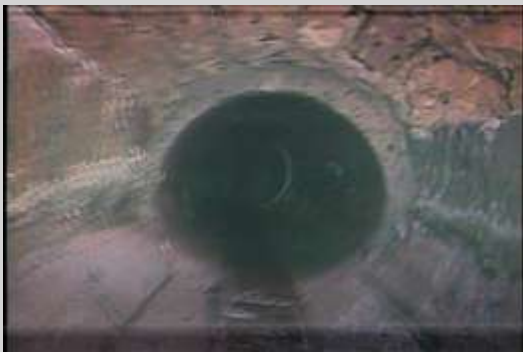
12 O'Clock Outflow

8 in. Circular Gravity Sewer  
Pipe Out @ 12 O'Clock

Pipe Height: **8.4** (in.) Rod and Bar (Angled)  
Pipe Material: **Clay** ☐ Pipe Lined  
Invert Depth: **8.50** (ft.) Flow Characteristics: **Slow**  
Deposits: ☒ None ☐ Mud ☐ Sludge ☐ Debris ☐ Grease  
Silt Depth: **0** (in.) Deposits Extent:  
Infiltration: **None** Pipe Seal Cond: **Sound**

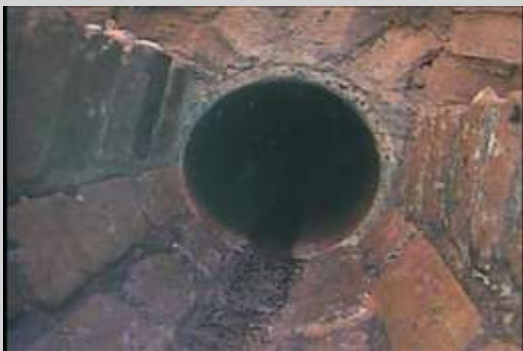
6 O'Clock Inflow

8 in. Circular Gravity Sewer  
Pipe In @ 6 O'Clock

Pipe Height: **8.4** (in.) Rod and Bar (Angled)  
Pipe Material: **Clay** ☐ Pipe Lined  
Invert Depth: **7.40** (ft.) Flow Characteristics: **Slow**  
Deposits: ☒ None ☐ Mud ☐ Sludge ☐ Debris ☐ Grease  
Silt Depth: **0** (in.) Deposits Extent:  
Infiltration: **None** Pipe Seal Cond: **Sound**
